Manhole Inspection Summary

Manhole # S17K__025MH

Location Address: **2543 franklintown-alley-catherine**

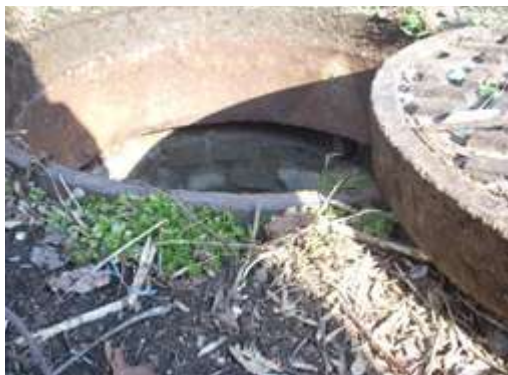
Misc

Cover Shape: **Circular** Diameter: **24** (in.) Length: **0** (in.) Dist A/B Grade: **1** (in.)

above grade (grass is obscuring the view a bit)

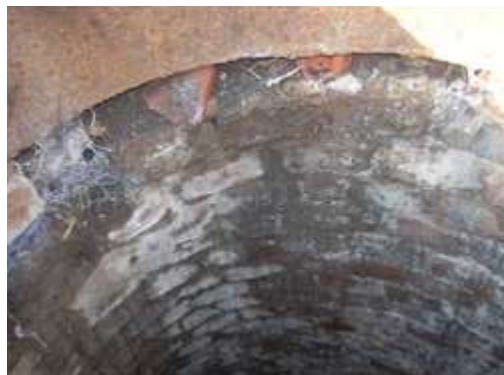
Defect 6

Infiltration: ☐ None ☒ **Joint** ☐ Cracks ☐ Mortar ☐ Roots ☐ Wall

infiltration evidence at the joint

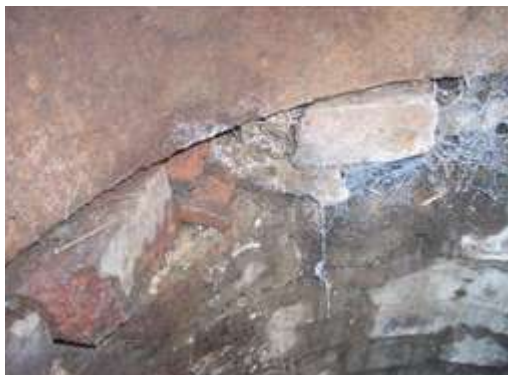
Defect 5

Condition: ☐ Sound ☐ Cracked ☐ Root Intrusion ☒ **Loose Brick** ☒ **Deteriorated**

loose chimney bricks

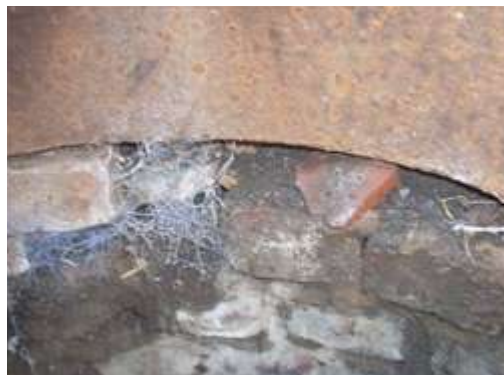
Defect 4

deteriorated chimney

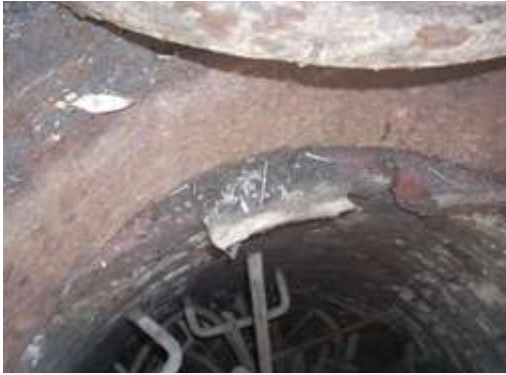
Defect 2

Frame Offset: **2** (in.) Condition: ☒ Sound ☐ Cracked ☐ Leaks

frame offset

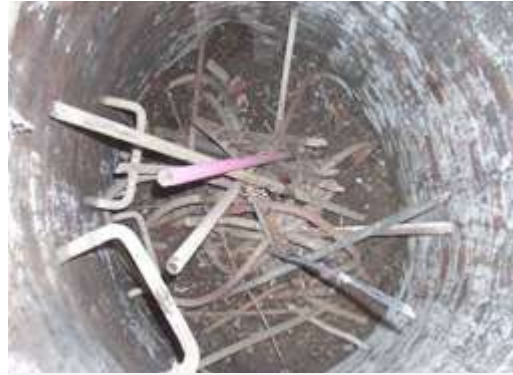
Defect 1

Condition: ☐ Sound ☐ Cracked ☐ Root Intrusion ☐ Deteriorated ☐ Leaks ☒ **Debris**

debris in the channel

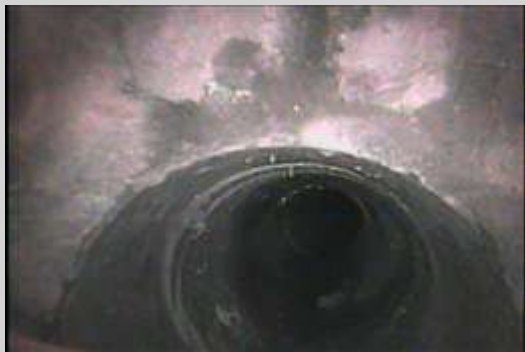
12 O'Clock Outflow

8 in. Circular Gravity Sewer
Pipe Out @ 12 O'Clock

Deposits: ☐ None ☒ **Mud** ☐ Sludge ☐ Debris ☐ Grease

Silt Depth: **1** (in.) Deposits Extent: **Light**

Infiltration: **Evidence** Pipe Seal Cond: **Sound**
